DEPARTMENT OF THE ARMY
HEADQUARTERS 589TH ENGINEER BATTALION (CONST)
APO San Francisco 96238

SUBJECT: Operational Report of 589th Engineer Battalion (Construction),
For Period Ending 30 April 1968 (RCS CSFOR-65(R1))

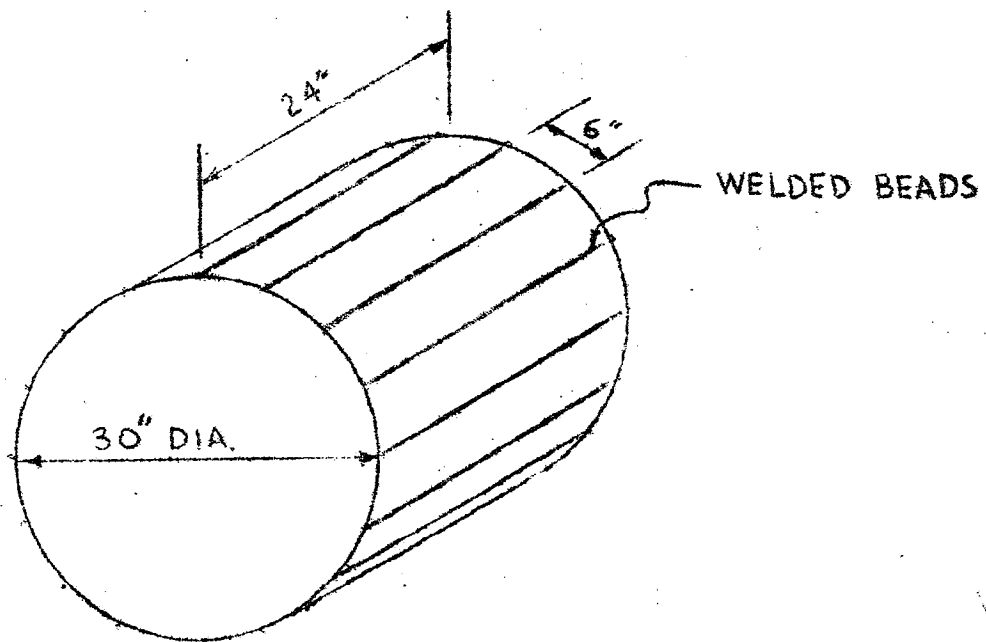
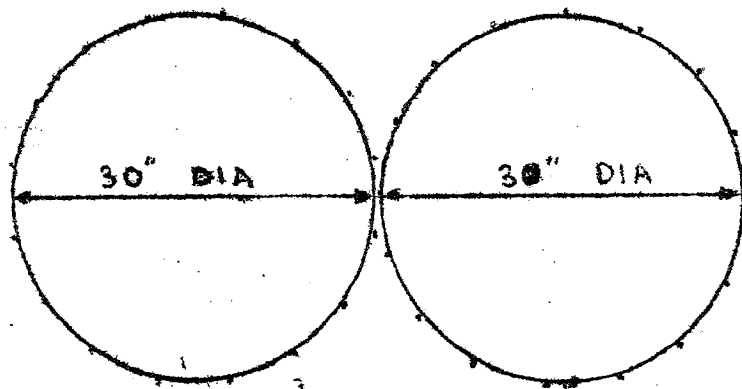
CRUSHER ROLLS

(b) EVALUATION. Fine aggregate, $\frac{1}{4}$ "(-), is needed to constantly supply the asphalt plant operation. The crusher was not producing $\frac{1}{4}$ "(-) material because the corrugations were of such a size as to allow minimum contact between the aggregate and the companion roll. The rolls were set as close together as possible but to no avail. It was found that by welding beads parallel to the axis of rotation on the smooth roll, gradation was improved and production increased.

(c) RECOMMENDATION. That hard surface beads be welded onto the smooth rolls of rock crushers when greater productivity and quality gradation are required.
